TECHNICAL PUBLICATION 80-7

PLANT COMMUNITIES OF THE KISSIMMEE RIVER VALLEY

Resource Planning Department
South Florida Water Management District
West Palm Beach, Florida 33402

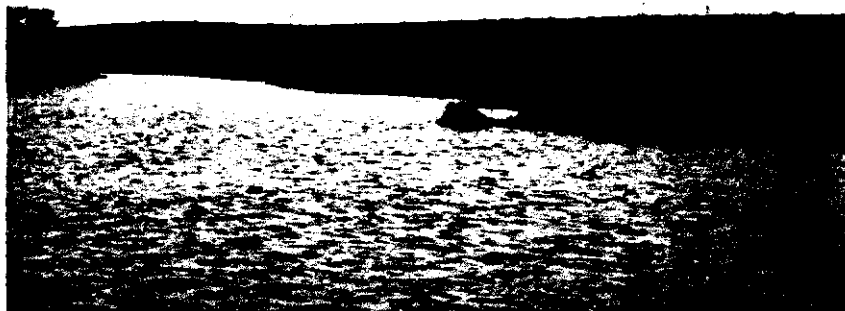
PLATE 21

VEGETATED SPOIL piles alongside C-38 have primarily become colonized with terrestrial species, such as grasses and dogfennel (*Eupatorium* sp).
